## FINAL REPORT

### Crushed Glass for Use in Asphalt Concrete or Cement Treated Base

71-27

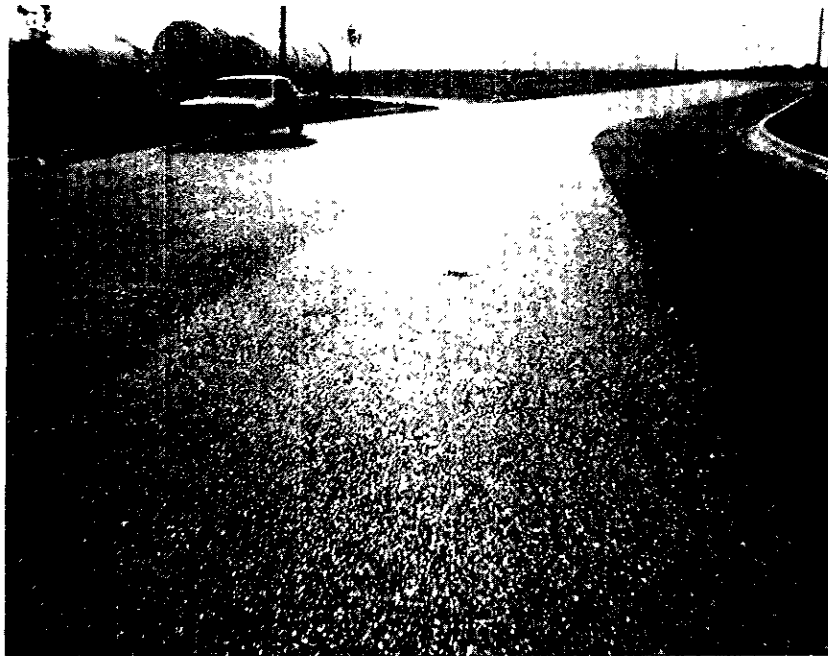
Photos Showing Glare on Glasphalt

The glasphalt pavement was visually inspected in January 1971, three months after construction. At this time, there was evidence of some raveling of glass from the mix by the presence of loose glass particles on the shoulders and in the gutters.

The glasphalt pavement was again visually inspected in April 1971. Prior to this inspection, the street had been hosed down and swept off. At the time of this inspection (about 5 P.M.) the street exhibited a definite glare (see attached photos). Close inspection showed that the asphalt had been removed from the top surface of the coarse glass asphalt. This removal apparently occurred during the aforementioned cleaning operation. A close inspection of the pavement also revealed that the coarse glass aggregate was fracturing and raveling in areas where vehicles were turning onto or off of the glasphalt. This would indicate that the glasphalt has low resistance to forces associated with turning and braking actions. This particular glasphalt street has had very little traffic and it is felt that considerable raveling might have occurred under even moderate traffic conditions. The portion of the street where glasphalt was only used in the base course is performing in a satisfactory manner and no distress is evident.
